RESULTS OF THE DEVELOPMENT MOTOR 8 TEST FIRING

HEARING

SUBCOMMITTEE ON SPACE SCIENCE AND APPLICATIONS

SEPTEMBER 16, 1987

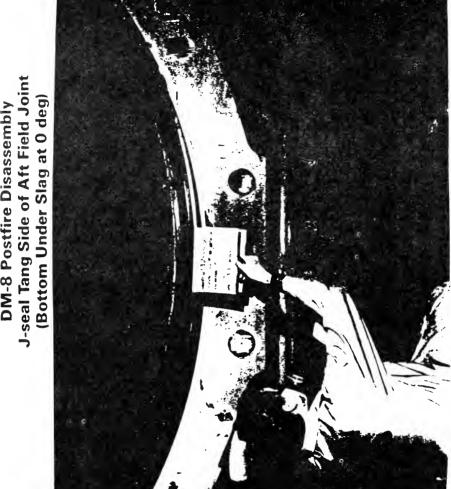
DM-8 Postfire Disassembly J-seal Tang Side of Aft Field Joint

cates J-seal functioned properly and

Visual inspection of field joints indi-

- Visual inspection from the inside motor showed perfect fit of J-seals
- Successful leak check verified integrity of O-rings after assembly
- Nicks observed in primary aft field joint O-ring. Occurred during disassembly at slag-induced heated area. No consequence to flight operation

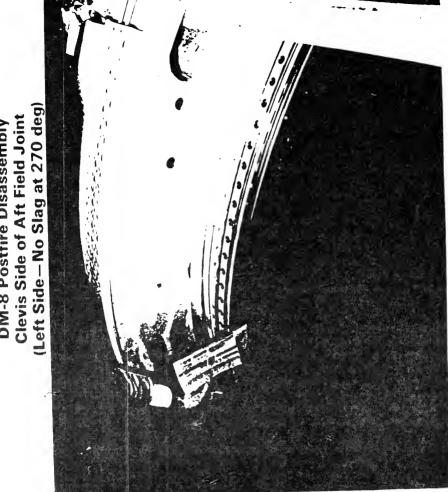
DM-8 Postfire Disassembly Clevis Side of Aft Field Joint

You can see the white heat effect on the NBR insulation, but again you can see down below that it is green, brown, which indicates that there was no leakage whatsoever past it. On the other side, the next photograph is a photograph of the opposite end of that joint, and there is nothing of any unexpected phenomena there. Again, the same clevis side joint on the following photograph.

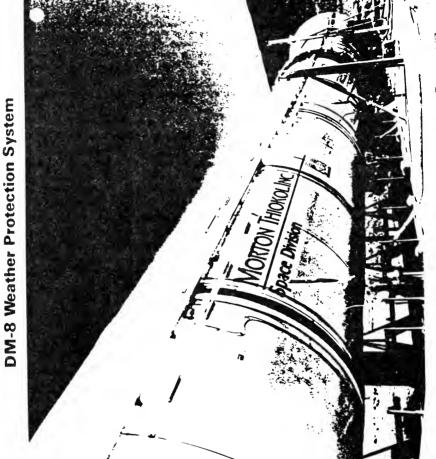
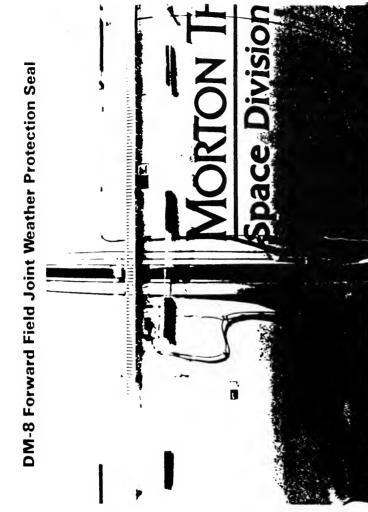
6. Evaluate effects of the leak check procedures on all field joint seals

No evidence of erosion or blowby detected during post-test inspection Heaters will not allow joint temperatures to fall

- Weather protection will remain securely attached to forward joint
- No evidence of damage
 to insulation, adhesive,
 or seals due to leak-test
 procedures detected
 during post-test inspection

- No blowby or erosion noted at field joint seals
- Heaters maintained joint temperatures of 82° to $104^{\circ}F$
- Field joints show no visual damage to J-seal, adhesive, or O-ring seals

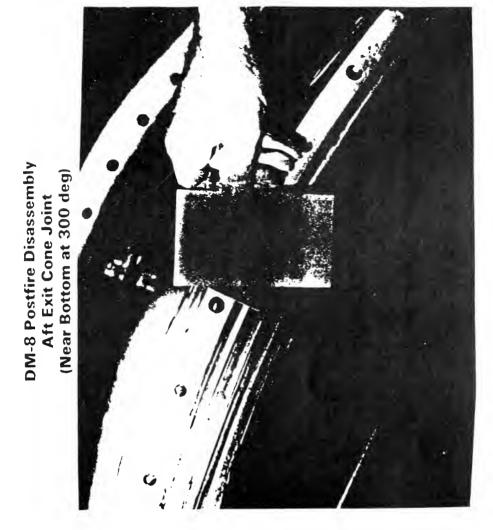
No hot gas to primary O-ring

RTV backfill eroded down 	to char line as predicted	and prevented hot gas	from reaching primary	O-ring of aft exit cone
--	--	---------------------------	-----------------------	-----------------------	-------------------------
